## HERITAGE BUILDING

# GOT IT PEGGED!

**Ashford and Cranbrook Roofing is demonstrating its command of craft skills on the repair of a traditional Kent peg tile roof. Professional Builder's Lee Jones talks to the company's Managing Director, Wayne Wills about this ancient trade.**

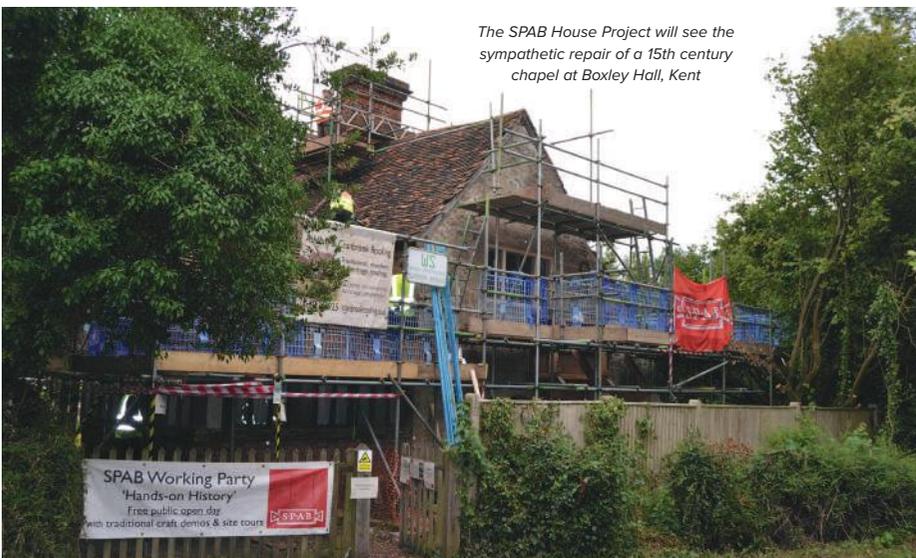
*The SPAB House Project will see the sympathetic repair of a 15th century chapel at Boxley Hall, Kent*

evaporation and air flowing around the tiles is also crucial to the longevity of a roof.” St Andrews Chapel is, in fact, an object lesson on past transgressions and the use of inappropriate materials. During its Post Office era, a nineteenth century extension to the original structure made use of felt as an underlay. As a result, moisture has been trapped, rotting the timbers and necessitating a complete re-roof of that section.

“It’s about being respectful of a building that’s been around for a lot longer than we have,” enthuses Wayne. “The SPAB brief is, of course, to repair wherever possible rather than replace which is why, on the main part of this roof, there will be no membrane – just Kent peg tiles and battens. There is the option of wood fibre boards, providing insulation from beneath, but at the same time ensuring that vital airflow under and through the tiles is maintained. Those tiles are inspected individually and repaired, with each section tested for its structural integrity. There is also evidence of roosting bats on the site, which has required a ridge construction through which they can access, whilst at the same time maintaining a water bridge. Complex roof are our stock in trade but they do require thought at every stage. We had to design the scaffold so that we’re not interfering with the roof in any way or breaking tiles, for instance, with a pole running the length of the ridge so that we can run a ladder from the scaffold onto that pole.”

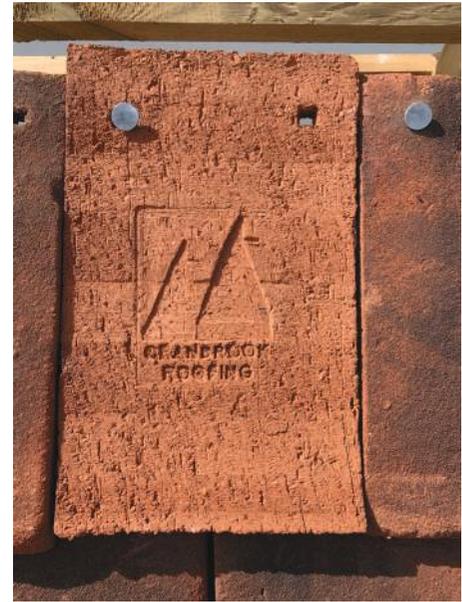
*An Ashford and Cranbrook Roofing tile with the company stamp.*

many of the clay tile manufacturers are producing the slight wider and longer versions, which are no good on heritage jobs like these. That's why we're now producing our own Kent peg tiles with our stamp on them. It is a product that has been used since at least the 14th century so it's certainly stood the test of time.”

It is King Edward IV who can thank for the dimensions of modern tiles, when his statute of 1447 decreed that they should be 10 ½ by 6 ¾in. and 5/8in. in width. Locally made Kent peg tiles did not, however, adhere to the standard until the late nineteenth century, which is why examples such as the SPAB house are 9 by 6in..
